RADC-TR-84-183
Final Technical Report
September 1984

EOS PROTECTION FOR VLSI DEVICES

Martin Marietta Denver Aerospace

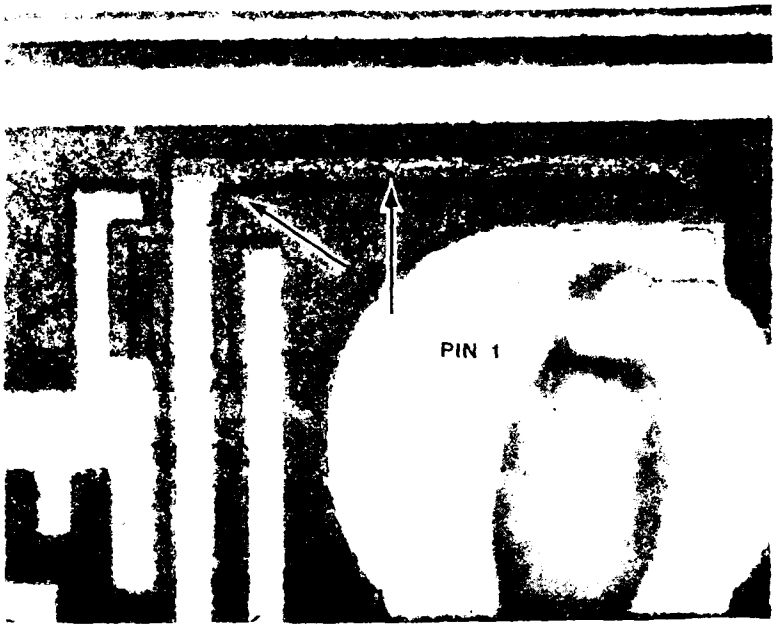
The polysilicon resistors do become damaged with stress as evidenced in Figure V.F.26. This limits their usefulness for input protection circuits. On this device the major limitation was the physical layout which allowed overlying metallization and input polysilicon to cross. There is little useful sensitivity variation information available from this device.

Figure V.F.26 - HBD Stress, Polysilicon Damage and Possible Short Site at Corner

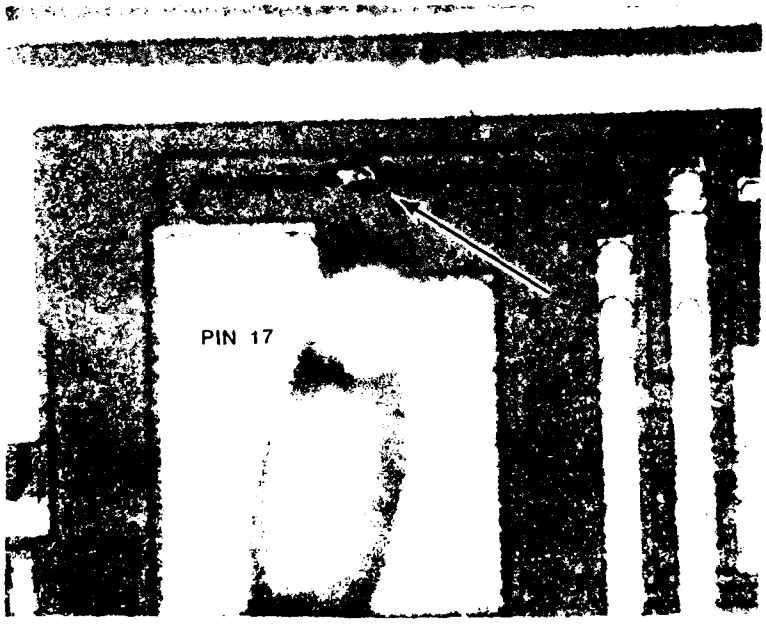
Figure V.F.27 - HBD Stress, Pin 17 Polysilicon Damage

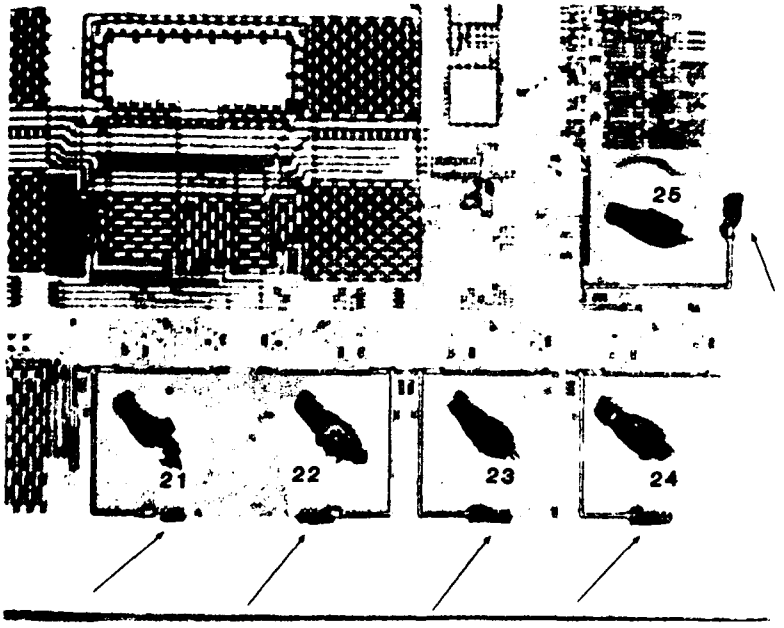
Figure V.G.23 - CD Stress, Damage at the Inputs

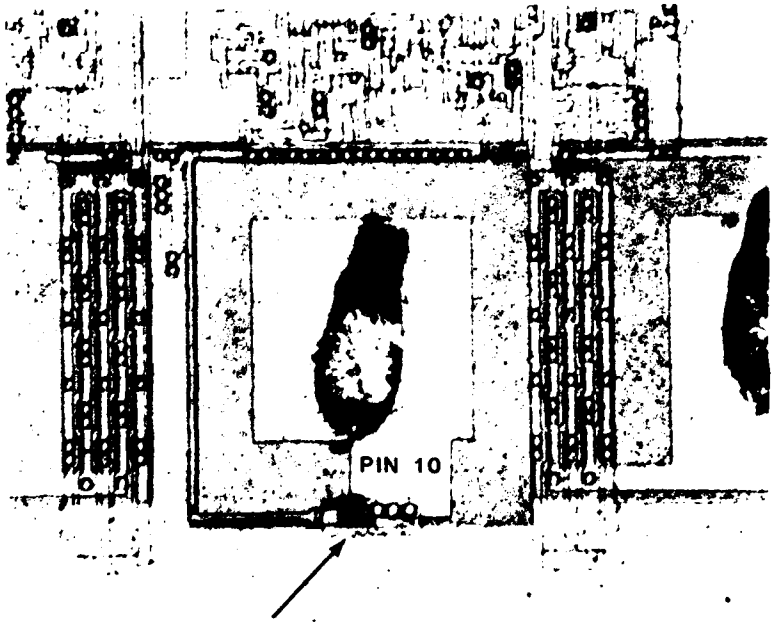
Figure V.G.24 - CD Stress, Damage at Pin 10 Inputs

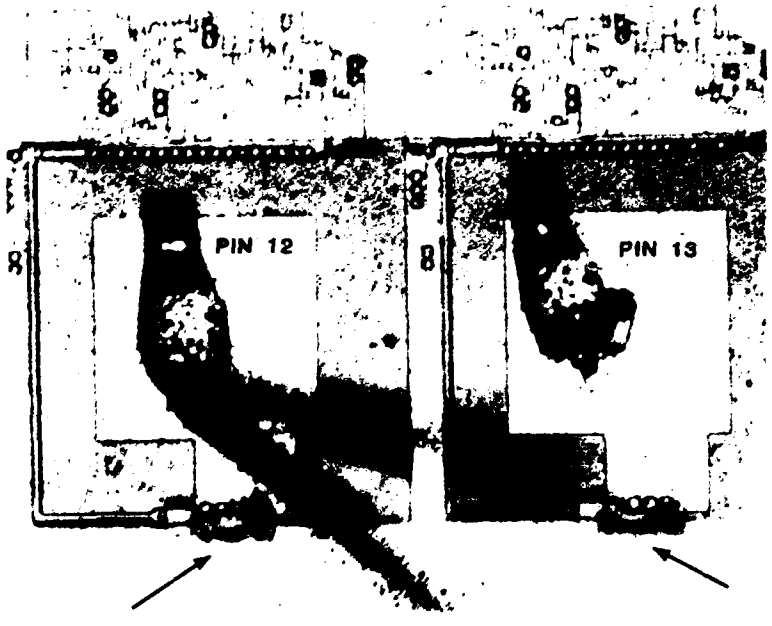
Figure V.G.25 - CD Stress, Damage at Pin 12 and 13

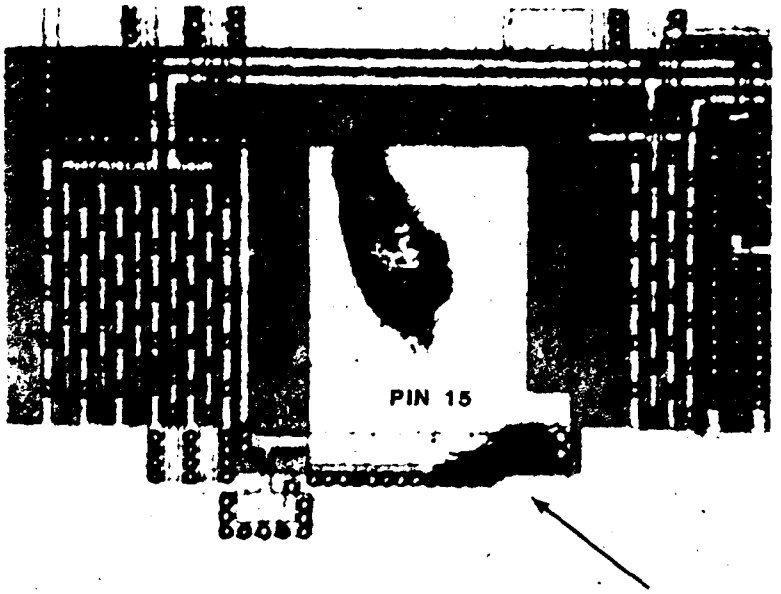
These parts were found to have inputs that were sensitive to stress due to damage created in the polysilicon interface between the bond pad and the input resistor. Pin 15 was the most sensitive to stress. This pin had a polysilicon stripe parallel to the protect resistor. This polysilicon was connected to ground and it also went beneath the bond pad metallization. The ground metallization represents a large capacitance and causes this pin to be readily damaged by the charged device model stress.

Figure V.G.26 - CD Stress, Damage on Pin 15

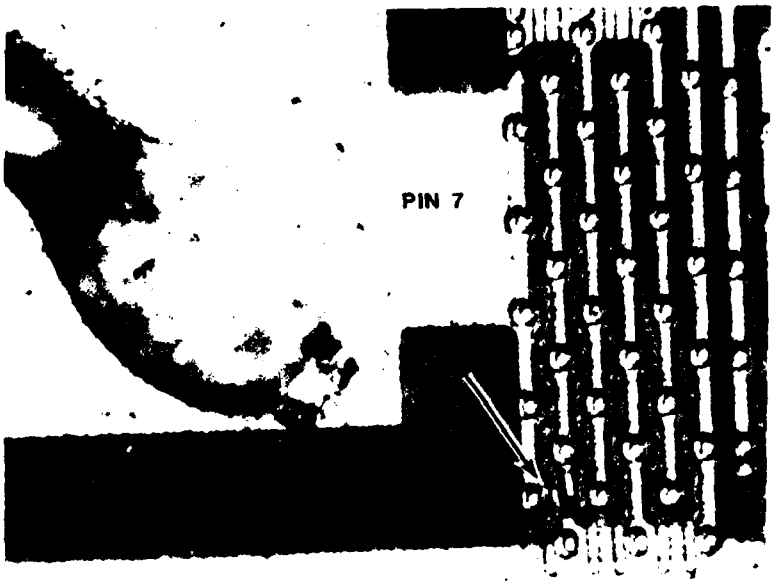
Figure V.G.27 - CD Stress, Short on Pin 7 Output

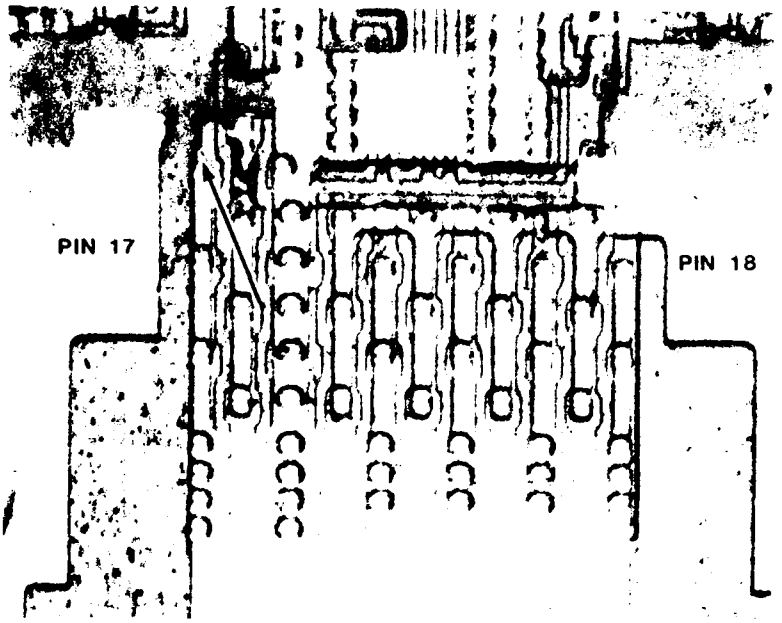
Figure V.G.28 - CD Stress,Pin 17 is Open to the Output Section and Pin 18 has Leakage Current

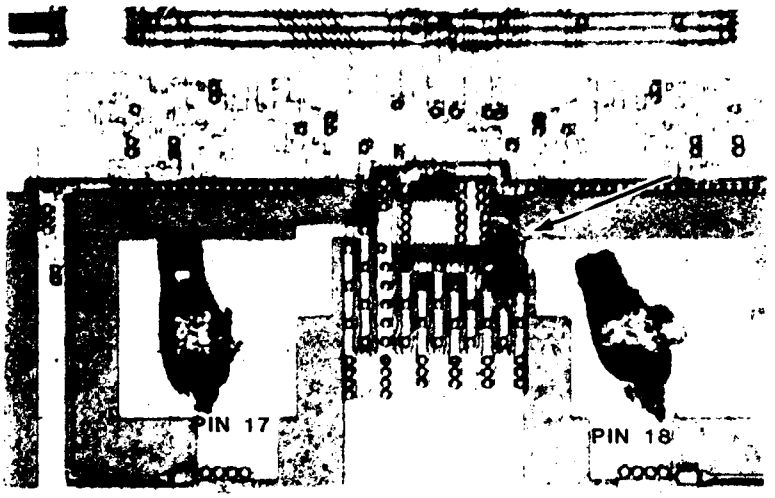
Figure V.G.29 - CD Stress Pin, 17 Has Leakage Current and Pin 18 is Open to the Output Section

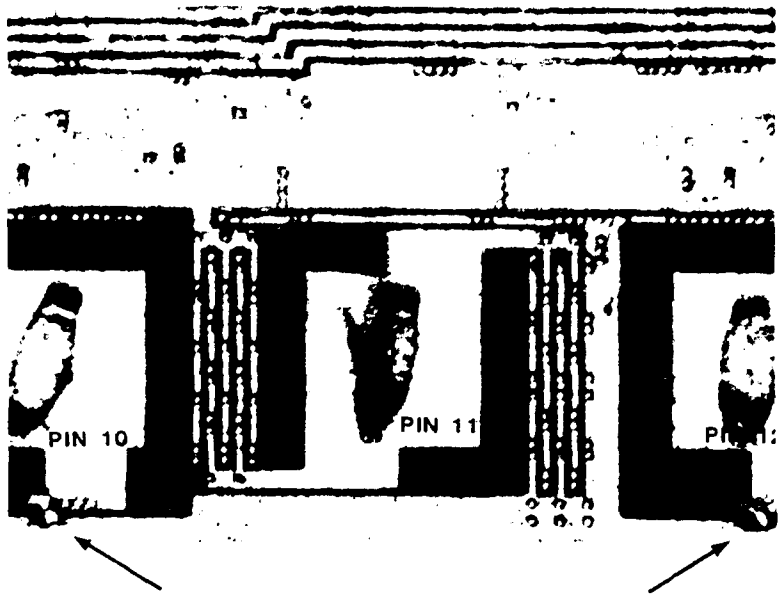
Photos of the type of damage that occurred is shown in Figures V.G.32 and V.G.33. Figure V.G.32 shows opens on pins 10 and 12. Figure V.G.33 shows slight visible damage on pins 22 and 23.

Figure V.G.32 - HBD Stress, Damage on Pins 10 and 12

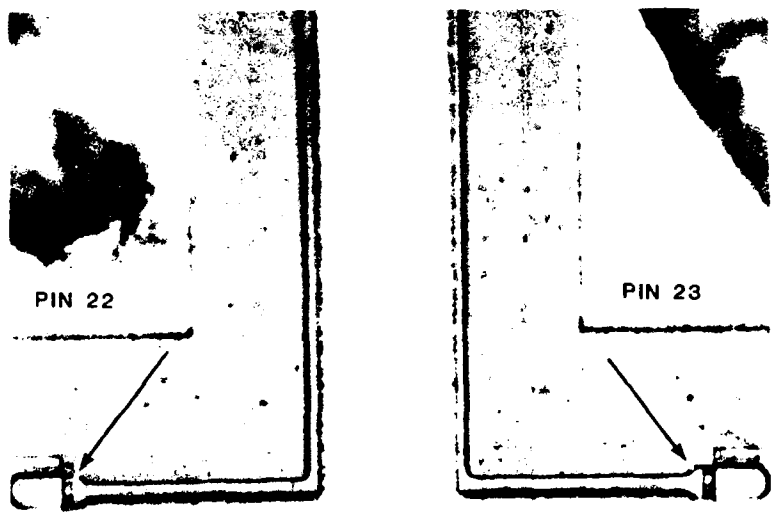
Figure V.G.33 - HBD Stress, Damage on Pins 22 and 23

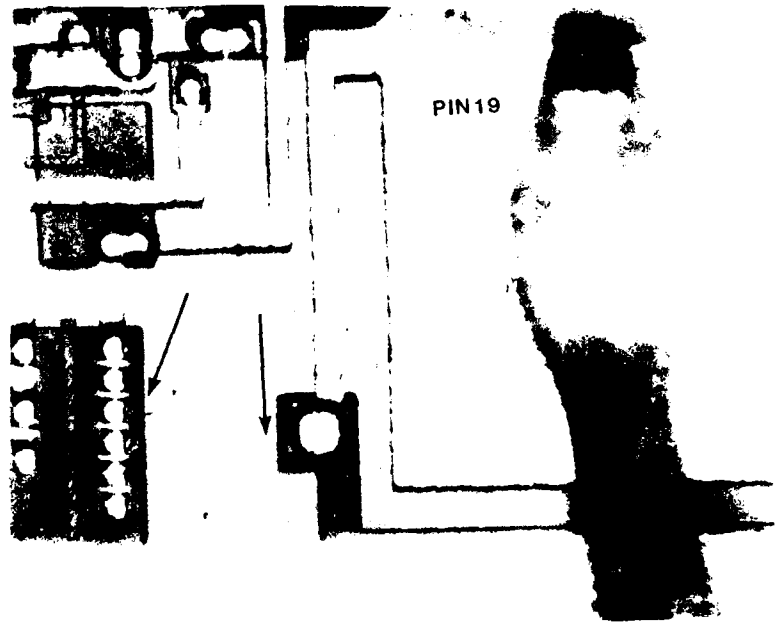
Figure V.H.26 - CD Stress, Electrical Damage from Pin 19 to Ground

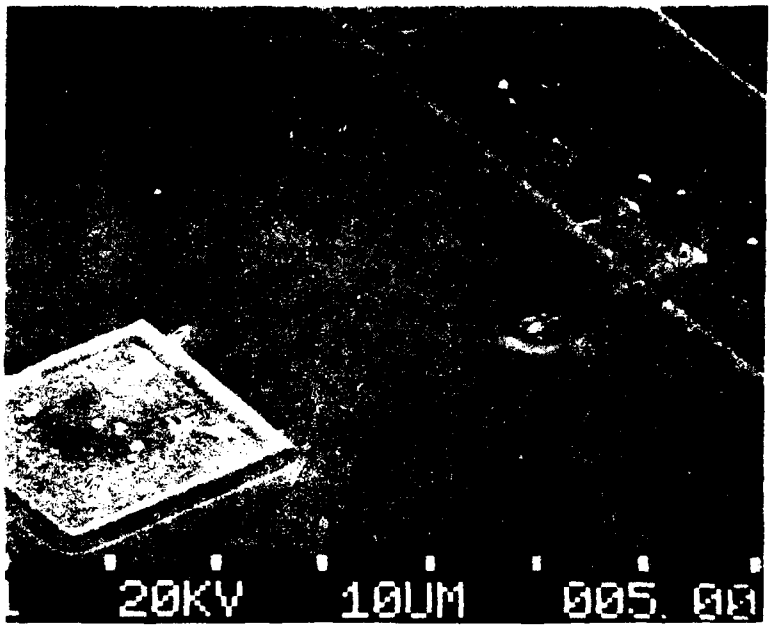
Figure V.H.27 - CD Stress, SEM Micrograph of Pin 19 Damage

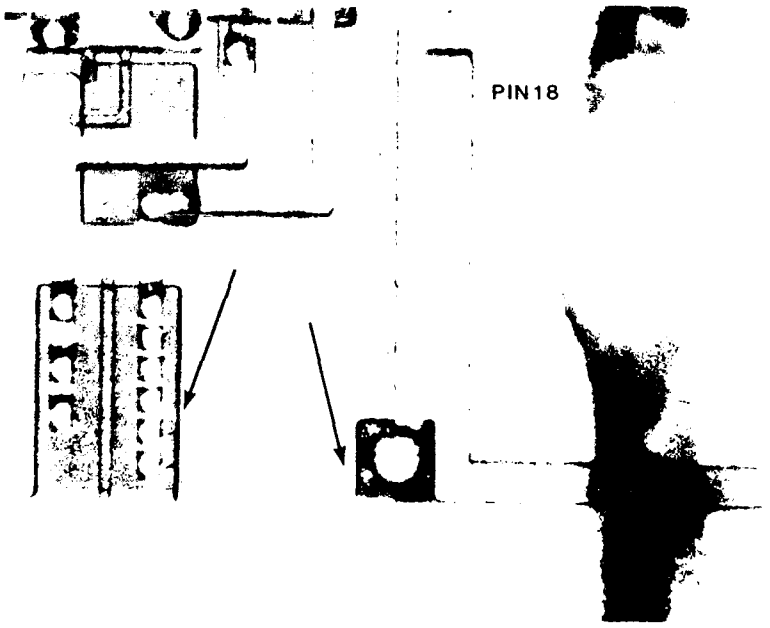
Figure V.H.28 - CD Stress, Pin 18 Degradation

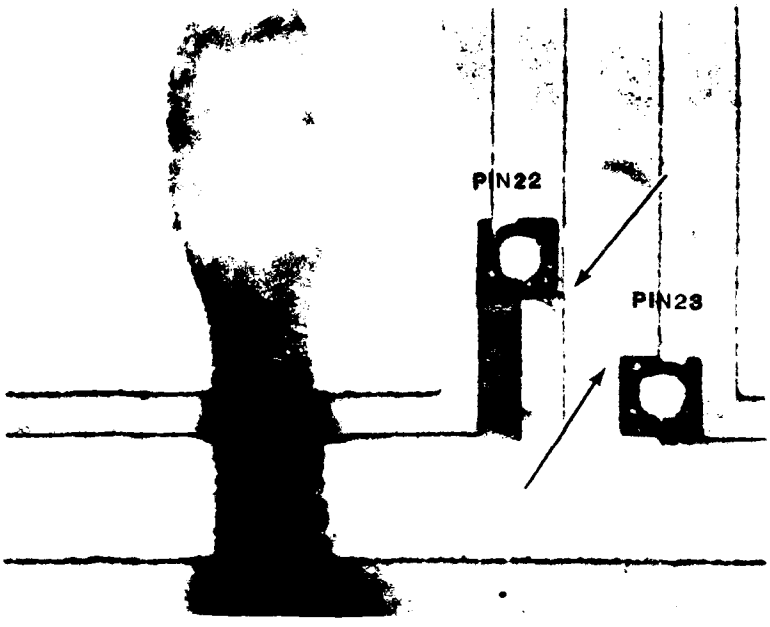
Figure V.H.29 - CD Stress, Pin 22 and Pin 23 Degradation

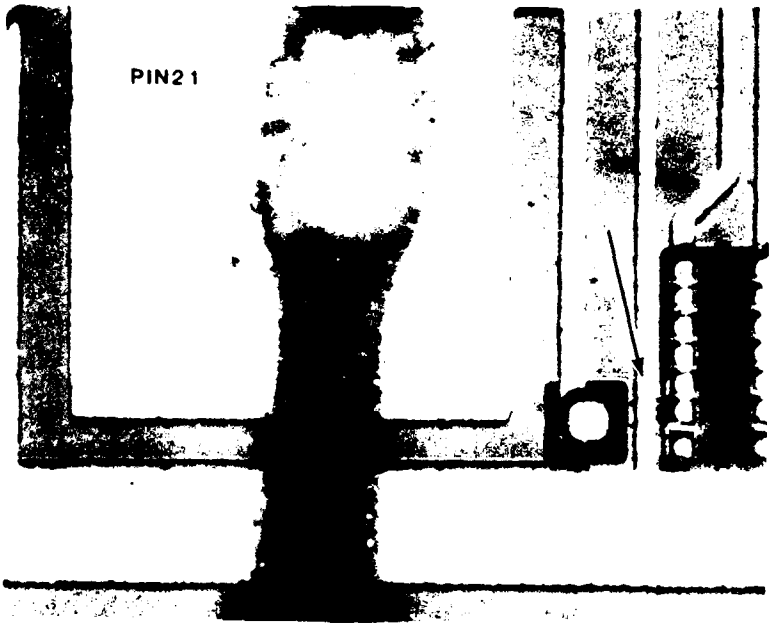
Figure V.H.30 - CD Stress, Pin 21 Damage

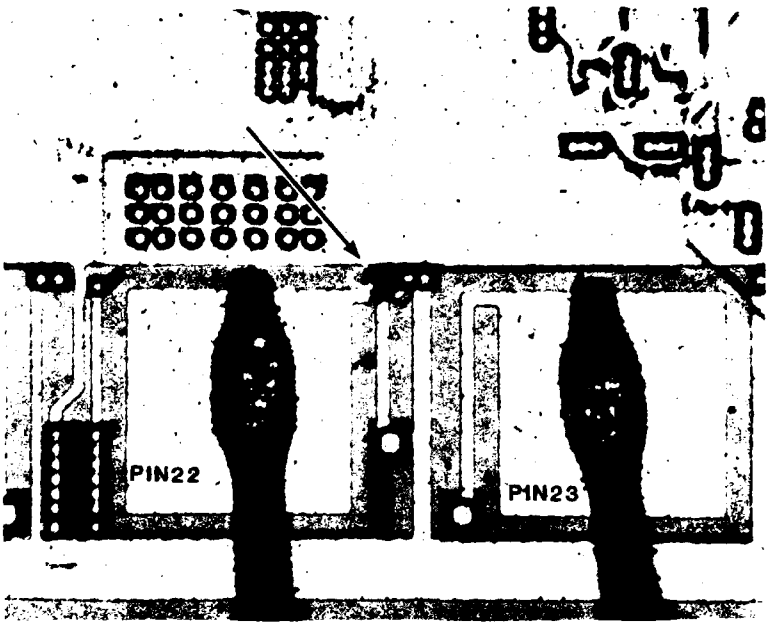
Figure V.H.31 - CD Stress, Open Metallization on Pin 22

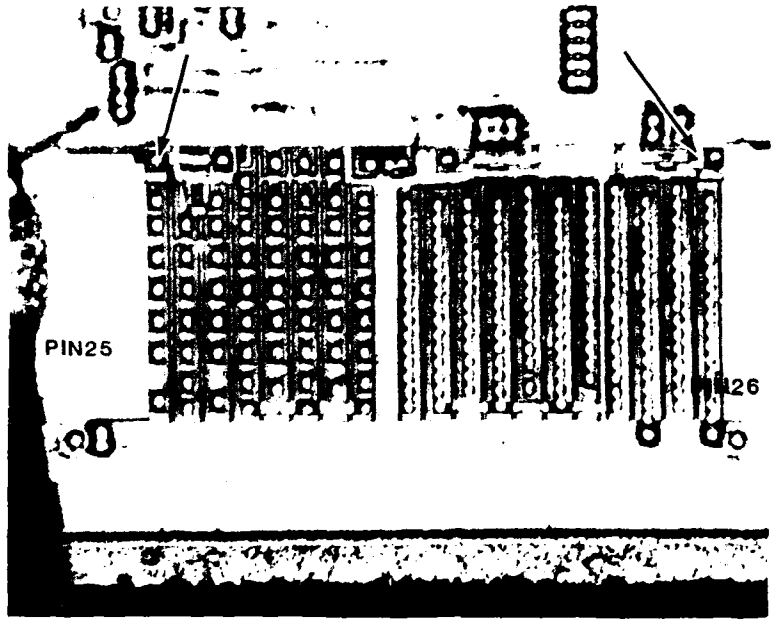
Figure V.H.32 - CD Stress, Pin 17 Shorted to Ground

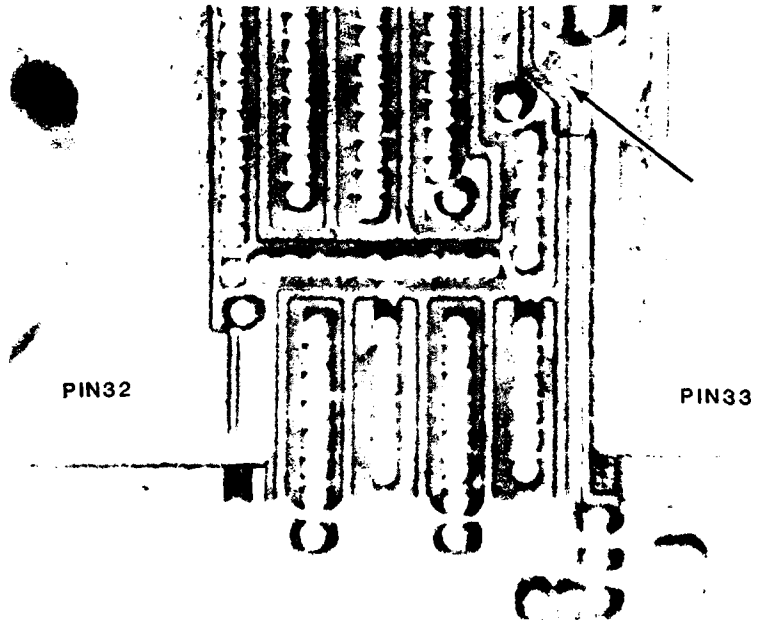
Figure V.H.34 - CD Stress, Damage Between Pins 32 and 33

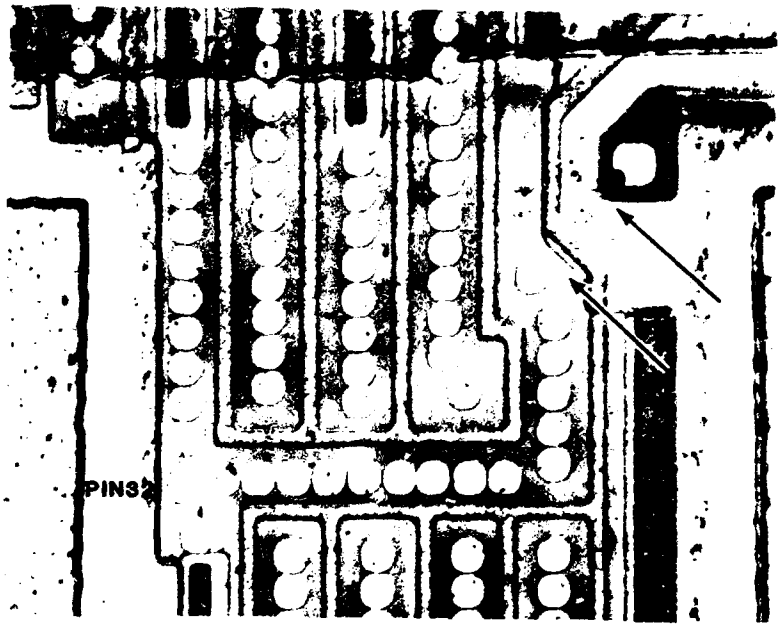
Figure V.H.35 - CD Stress, Same View as Previous Photo with Aluminum Stripped

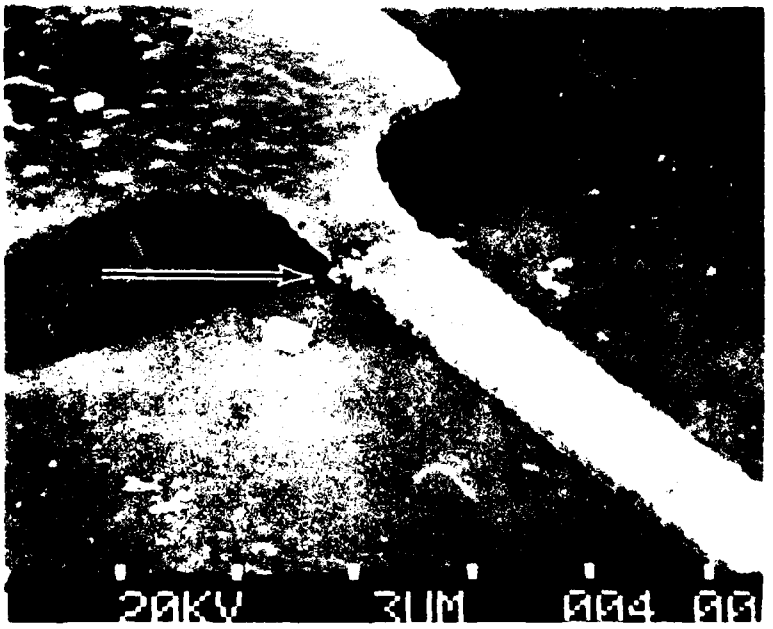
Figure V.H.37 - CD Stress, Pin 5 Polysilicon Breakdown Site

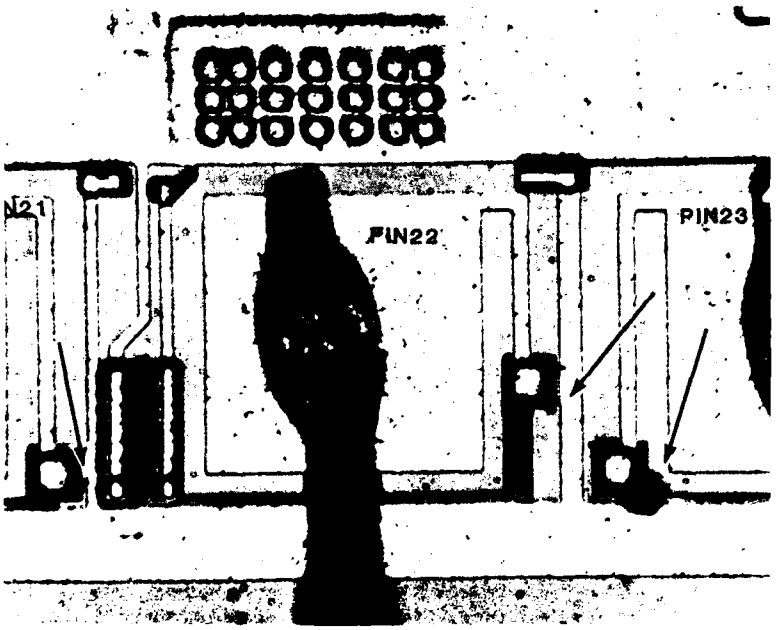
Figure V.H.40 - HBD Stress, Damage on Pins 21, 22, and 23

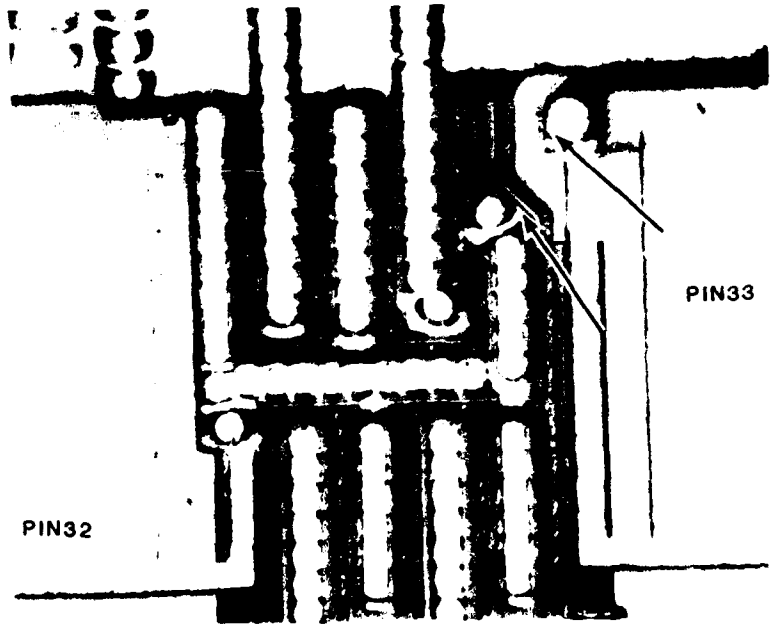
Figure V.H.42 - HBD Stress, Damage on Pins 32 and 33

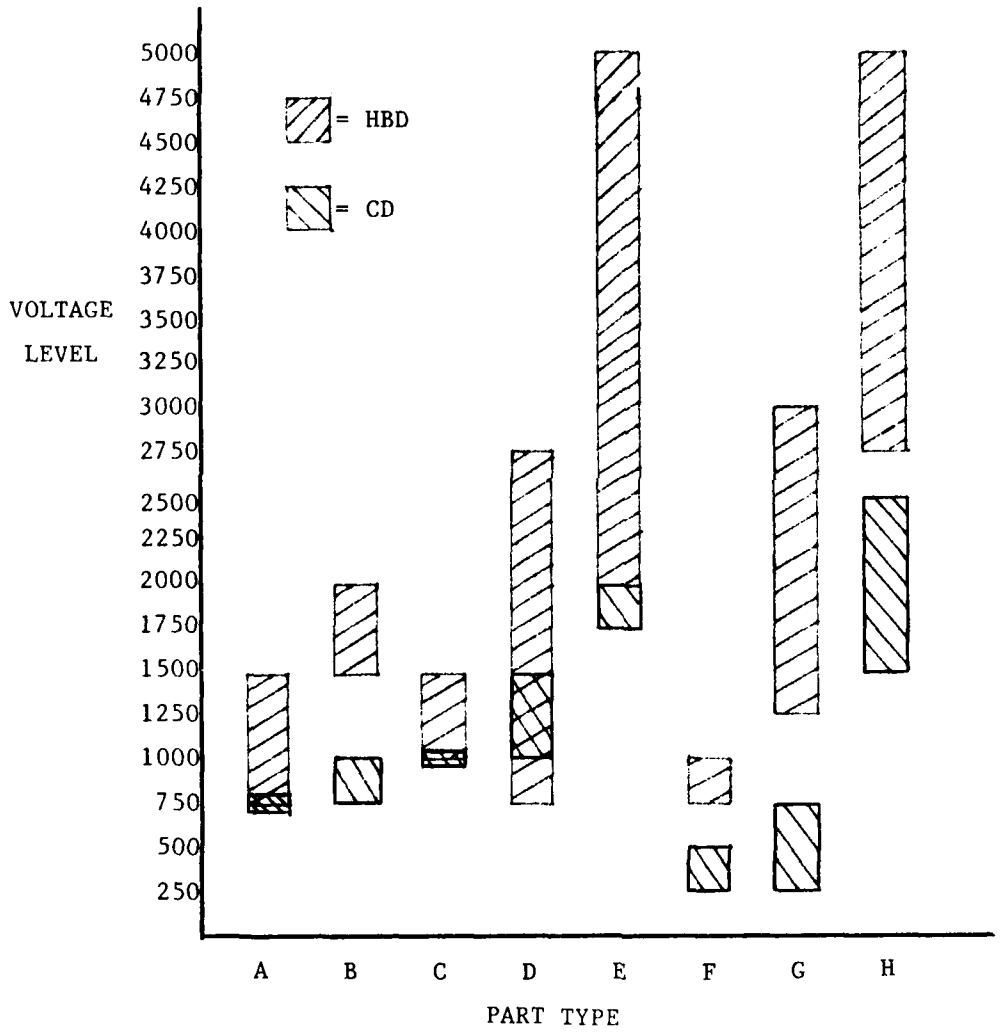
Figure VI-1 - Failures by Voltage Level For Each Part And For Both The Charged Device And Human Body ESD Models.

Figure VI-1 shows the voltage range at which parts were removed from test for all eight groups of devices and for both types of stress. Examination of this figure reveals a number of conditions. With the exception of Part D, parts always failed at a lower level for the charged device model. There was not always the same relationship between the level of the charged device failures and the human body failures. The two groups which had the best tolerance to the HBD stress did have the best tolerance to the CD stress, however, the other parts did not follow this pattern. Part G was very sensitive to the CD stress but was relatively high in tolerance to the human body stress. This is due to the significant effect of the package size on the CD stress. The Part G devices were in the largest package and had the highest capacitance to ground. This created a much higher stress for the same voltage level.
